SERIAL NUMBER: WADC-TR-52-68

DATE: April 1952

PHASE V (ALL WEATHER) TESTING OF T-29A AIRCRAFT

All Weather Section
Flight Test Division
Project No. S207-20

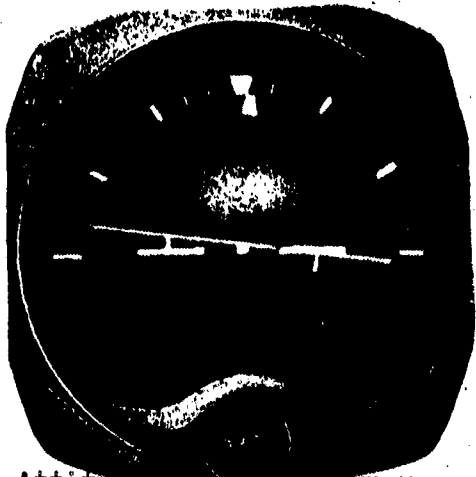
Attitude gyro after run-up and in take-off position following a 90° turn on to runway.

As noted in the illustration to the left, the horizon bar is displaced in both pitch and roll. The pitch error can be adjusted by moving the reference plane to coincide with the bar, but there is no way of adjusting the roll error. Most pilots are capable of interpreting this error, although it does impose an additional workload at a critical time and thereby jeopardizes the instrument take-off. If a vertical gyro (J-8) incorporating a manual erection knob is installed, the pilot can center the horizon bar and eliminate the turn error.

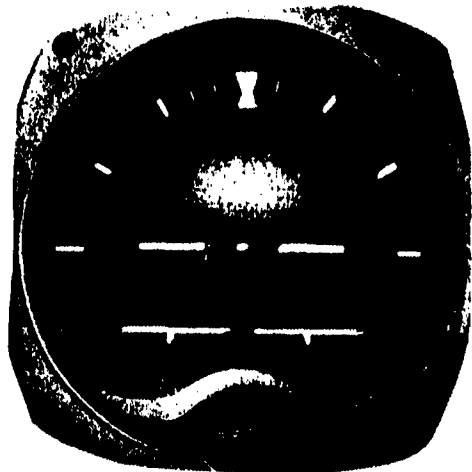
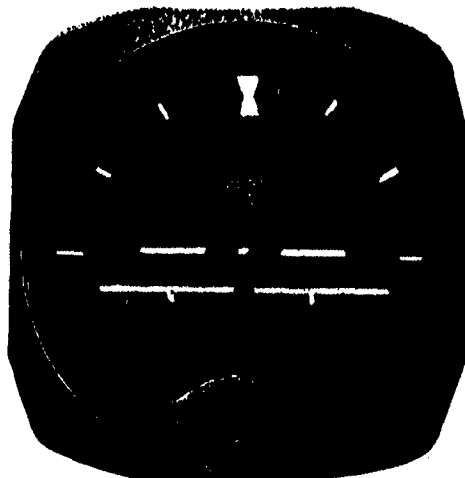
The attitude of the aircraft at recommended VFR climbing speed (122K) is $22\frac{1}{2}^{\circ}$ nose up; however, the presentation of the A-2 Vertical Gyro at this speed makes it difficult to maintain this attitude in instrument flight. For ease of operation, instrument climbs were made at 140K which gives a more flyable presentation on the attitude indicator, as noted in the following illustrations.

Attitude Gyro at climbing speed - 122K

Attitude Gyro at climbing speed - 140K

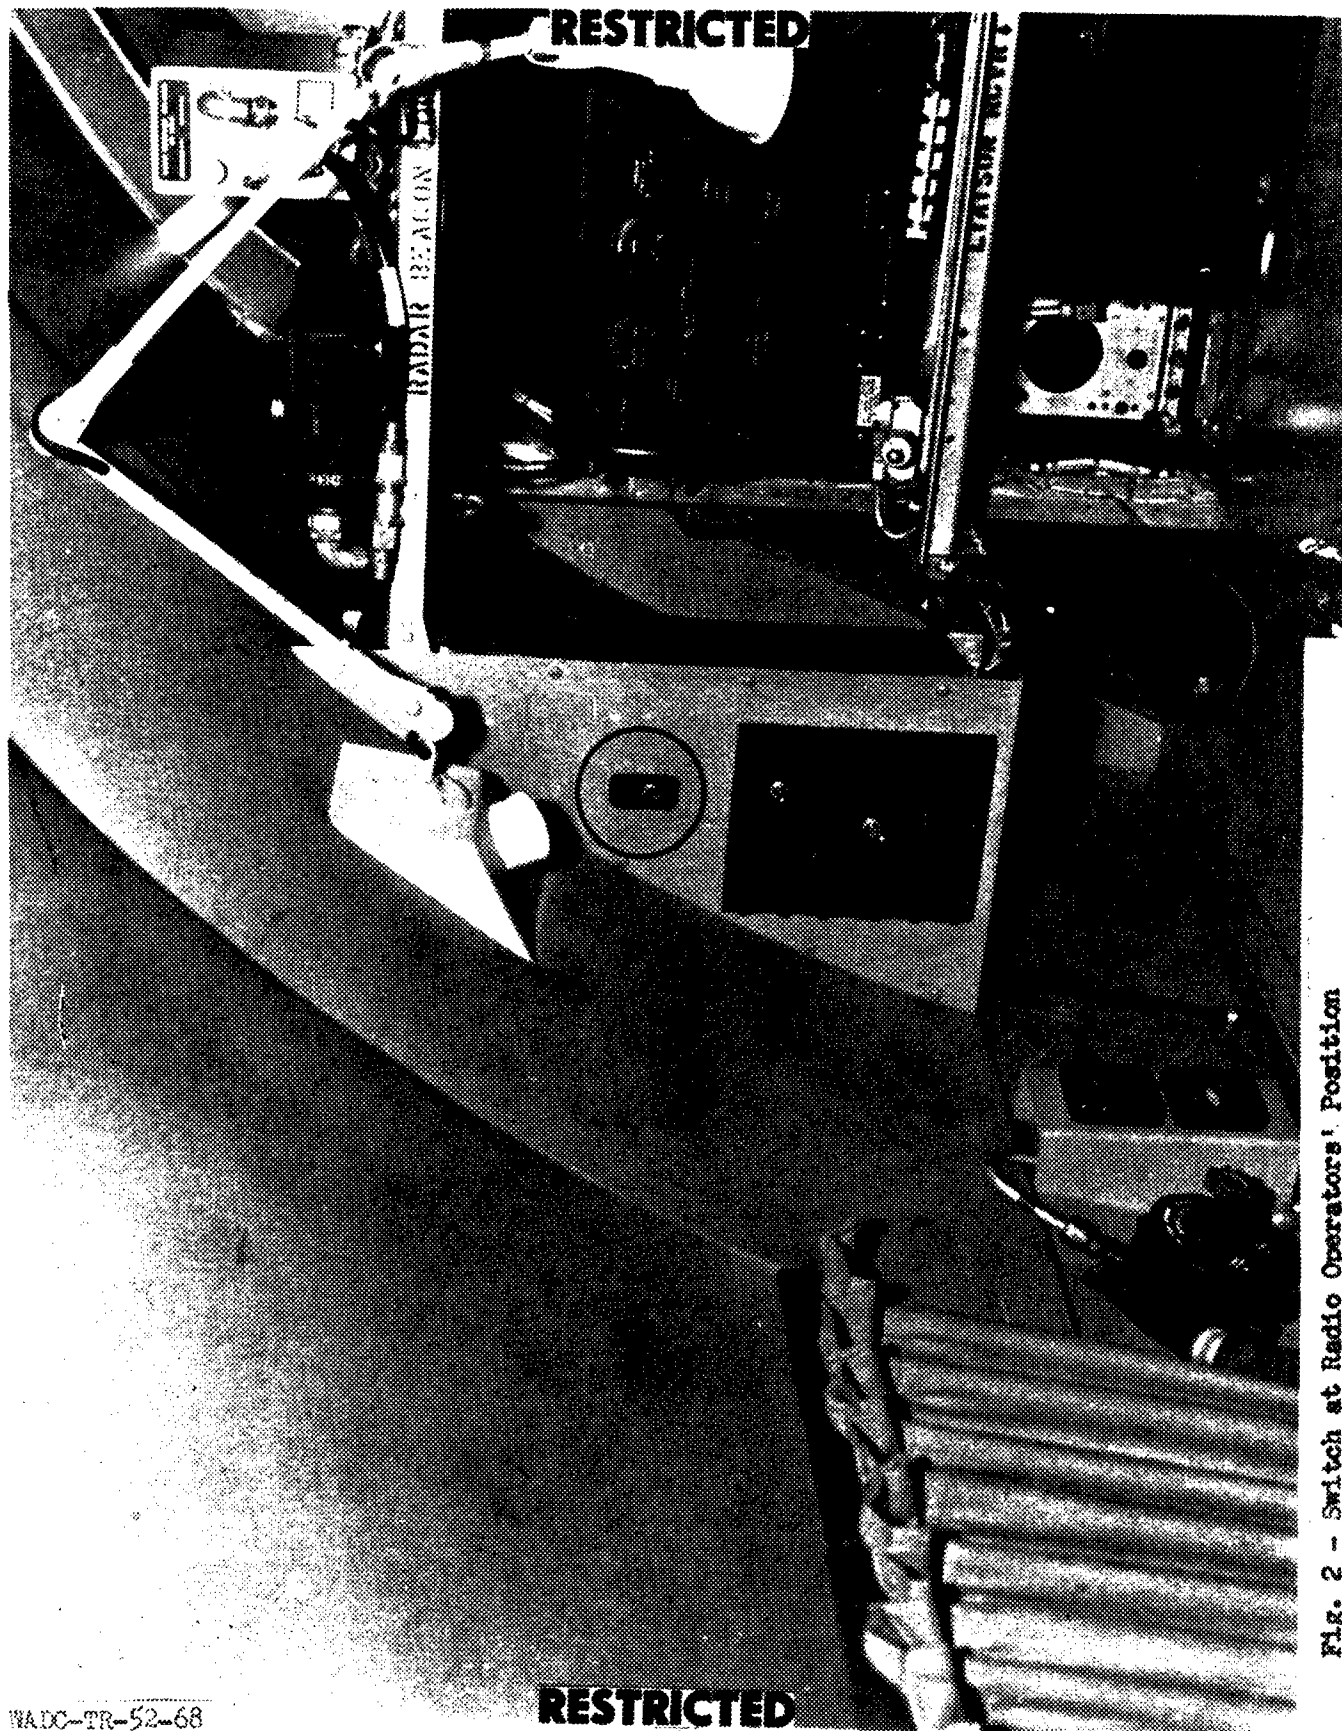
Fig. 2 - Switch at Radio Operators' Position

The cross pointer indicator (I-101-C), the marker beacon, and the command radio are connected through a switch at the radio operator's position, (See Fig 2) and by inadvertently operating this switch, the radio operator could turn off the pilot's equipment enumerated above. The operation of the above equipment is further jeopardized because the power source is derived from the secondary bus bar. In the event of engine failure, the overload switch cuts this equipment out of the circuit and it is necessary to override the overload switch. Since there were no warning flags on the cross pointer meter of the test aircraft, the pilot had no indication that the system had failed. On one approach it appeared that the aircraft was on the glide path and only because the pilot was monitoring the ADF did he know that the system was inoperative.

9. Eliminate the switch on the radio operator's panel that controls the command radio, cross pointer meter, and the marker beacon.

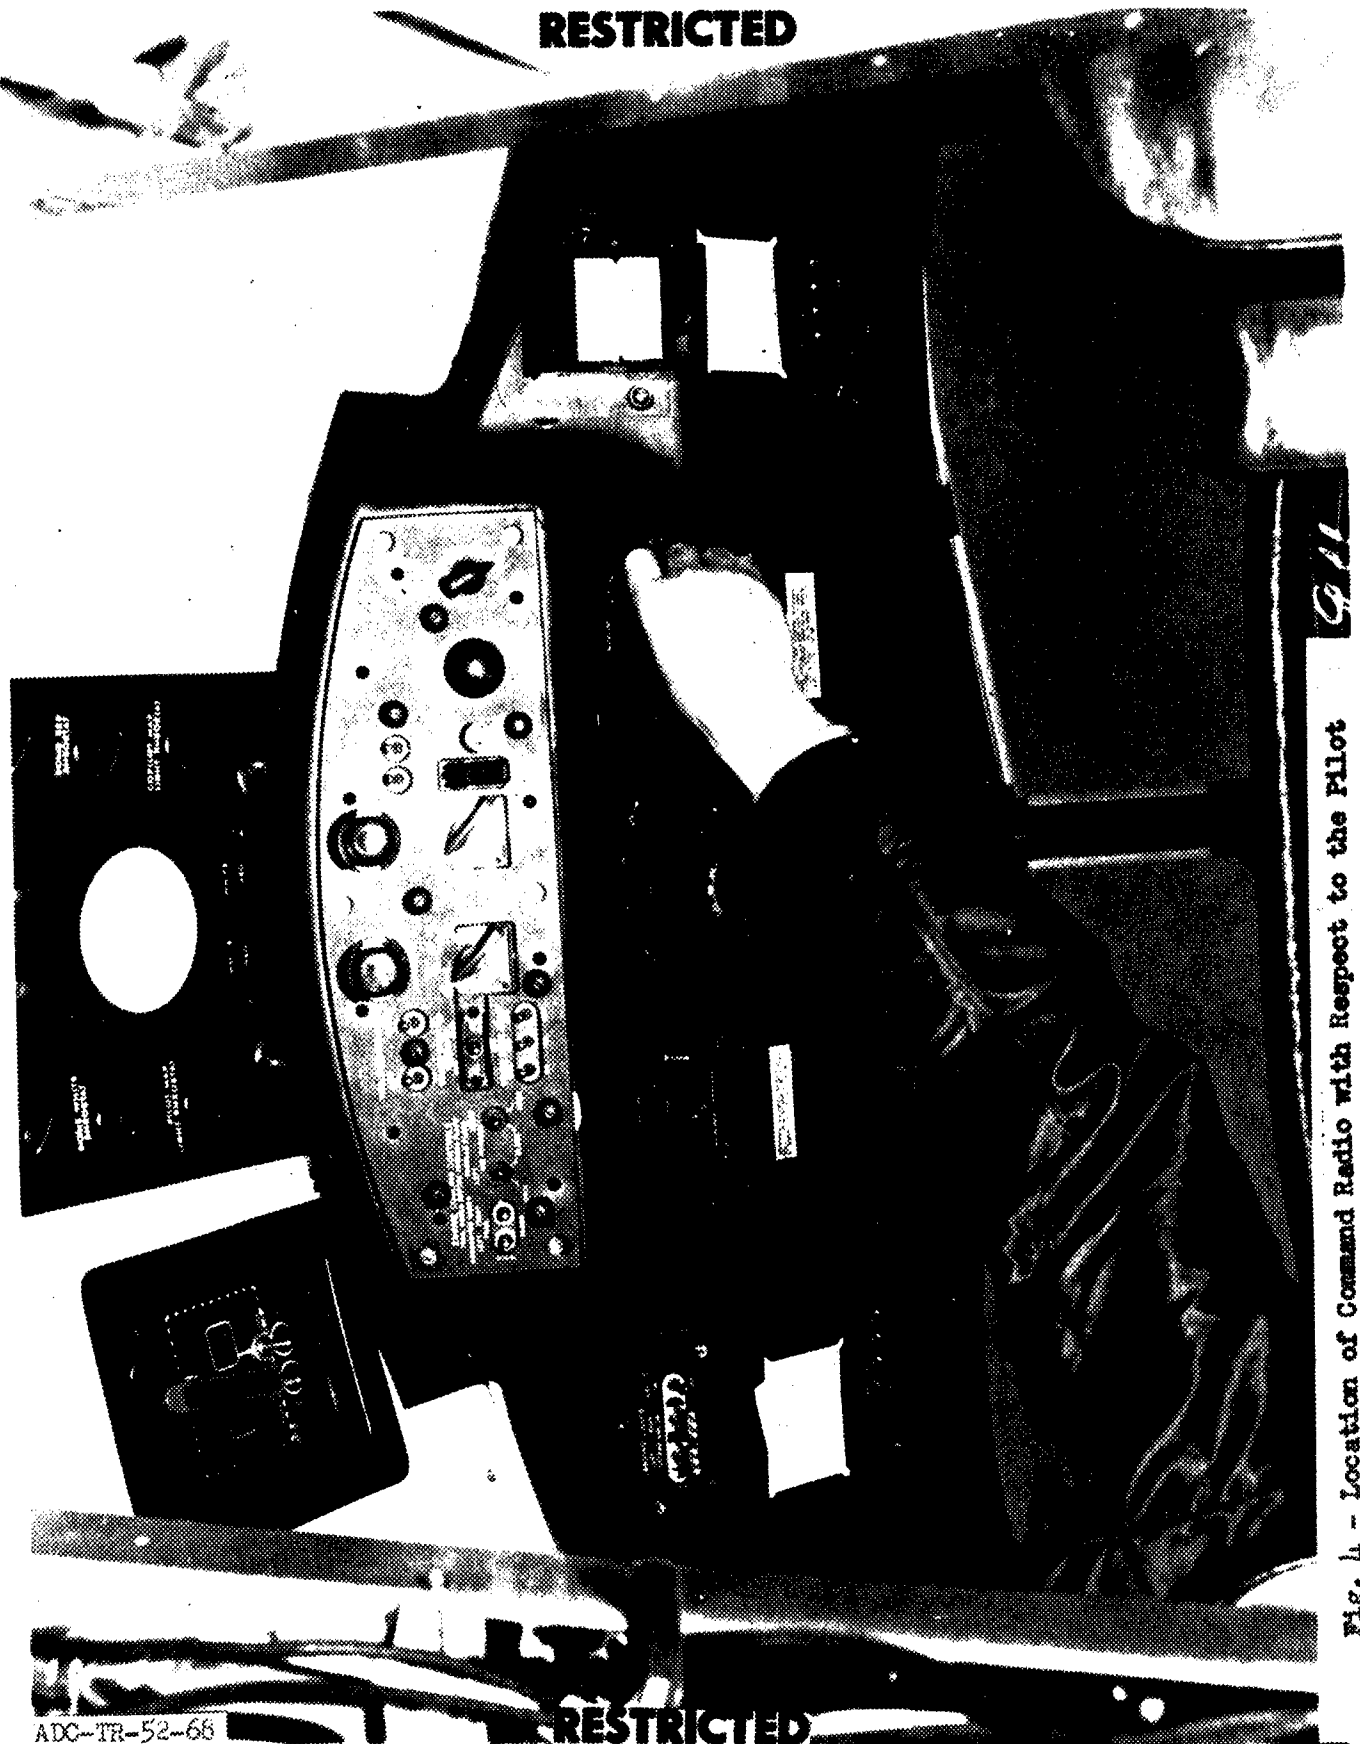
Fig. 4 - Location of Command Radio with Respect to the Pilot

The command radio control box which is normally used by the pilot for range approaches operates satisfactorily, but it is inconveniently located on the far side of the radio panel. In this location the volume control is not readily accessible to the pilot. (See Fig 4).

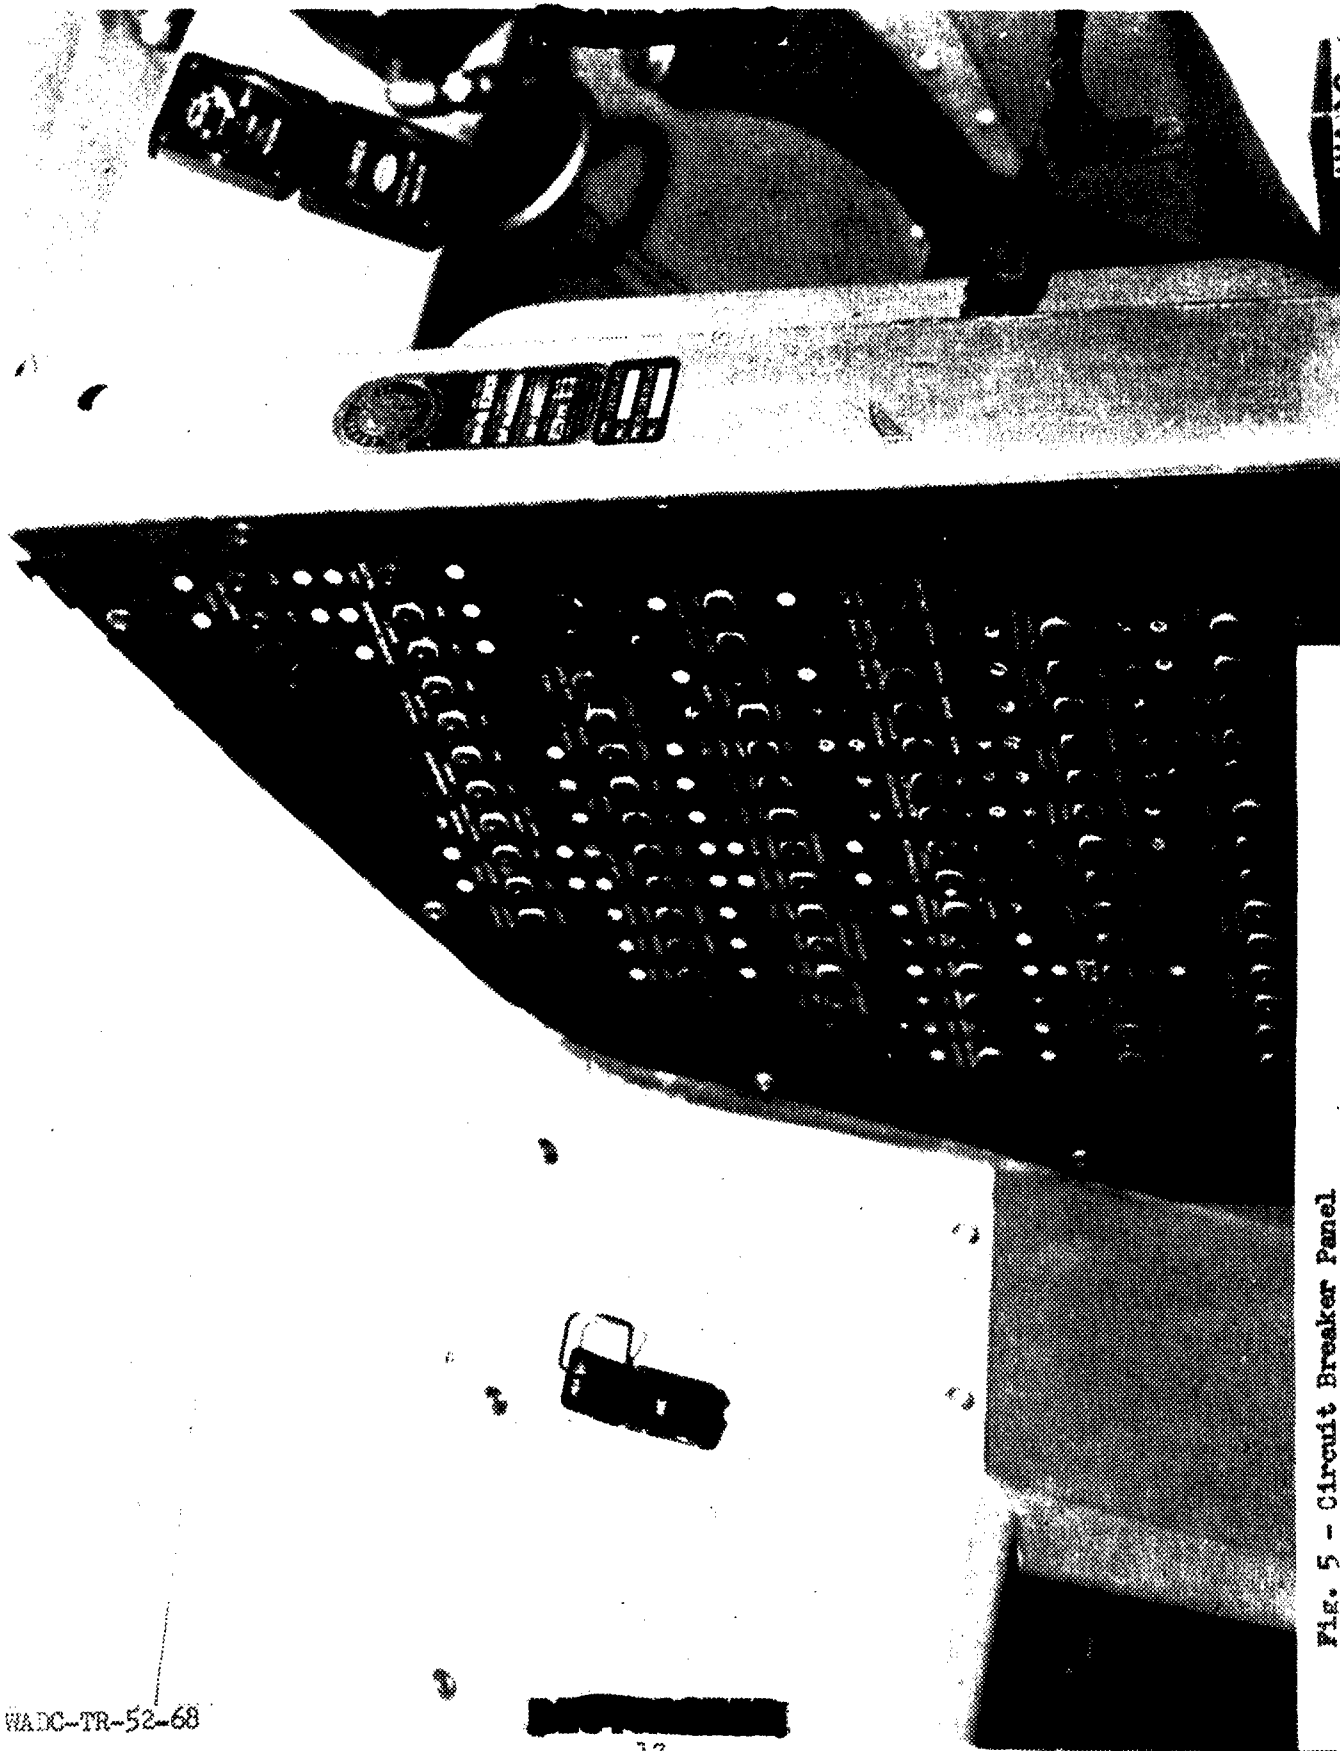
Fig. 5 - Circuit Breaker Panel

- (1) The circuit breaker panel behind the copilot is unlighted and, when flying at night, it is necessary to use either the dome light or a flashlight to check the circuit breakers. (See Fig 5).
- (2) The trim tab indicators are unlighted.
- (3) The white flood light, installed on the pilot's dome light panel and actuated by the switch on the pilot's and copilot's control wheel, satisfactorily floods the cockpit with light. However, by inadvertently touching the switch on the wheel, as has often been done, both the pilot and copilot are distracted. There is seldom, if any, occasion to momentarily use this light.

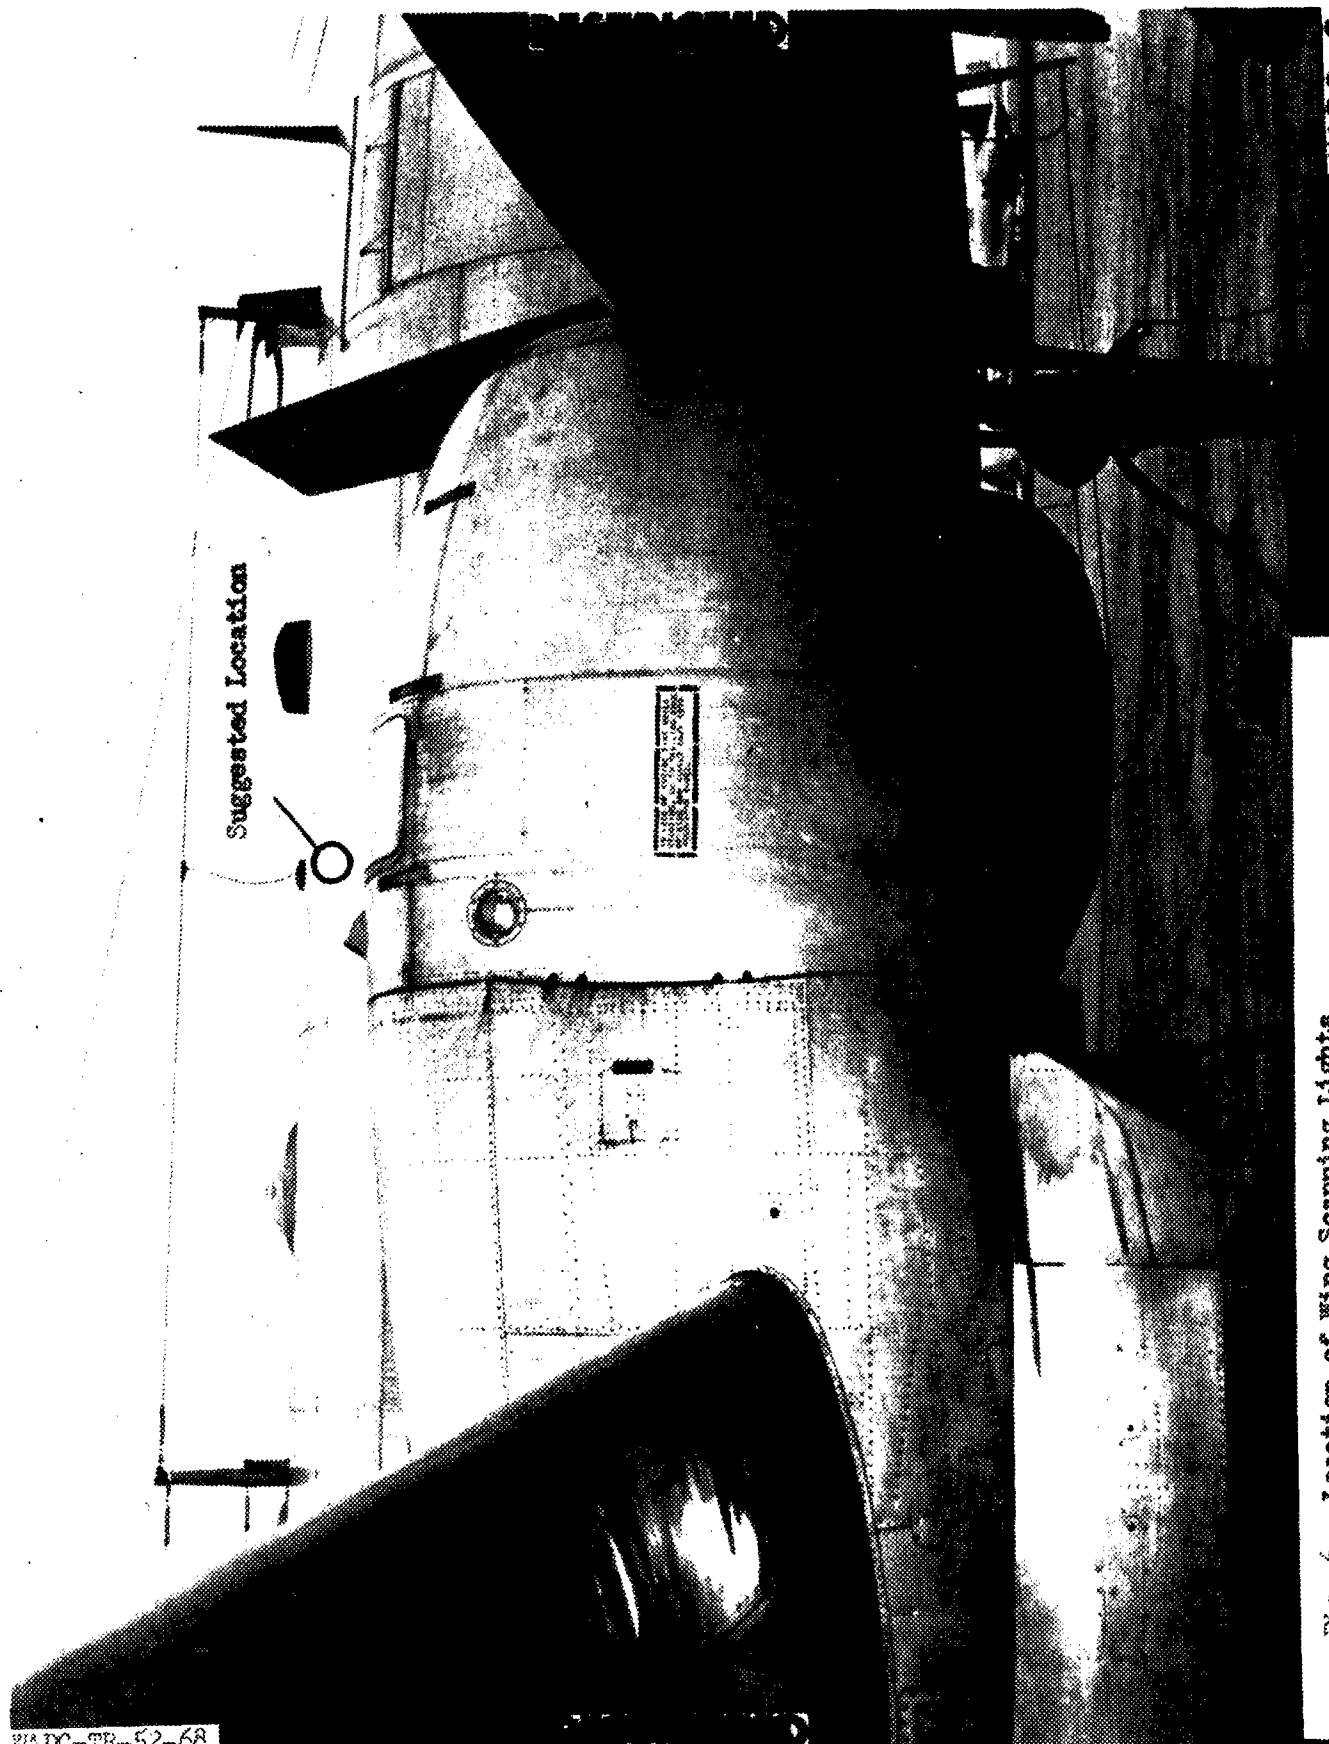
Fig. 6 - Location of Wing Scanning Lights

- (1) The exterior lighting is satisfactory.
- (2) The taxi light, mounted on the nose-wheel strut, is excellent for use during ground operation. It turns with the nose wheel and enables the pilot to locate the taxiways after landing. It also saves an immense drain on the battery which normally results when using the landing lights for taxiing.
- (3) The wing scanning lights, located outboard of each engine nacelle, are excellent for determining wing icing during flight at night. Their useful function could be enhanced by placing them in the upper portion of the fuselage. In this position it would enable the pilot to scan the engine nacelles for oil leaks as well as ice build-up on the wings. (See Fig 6).

19. Relocate the scanning lights from their present location to a position near the top of the fuselage.

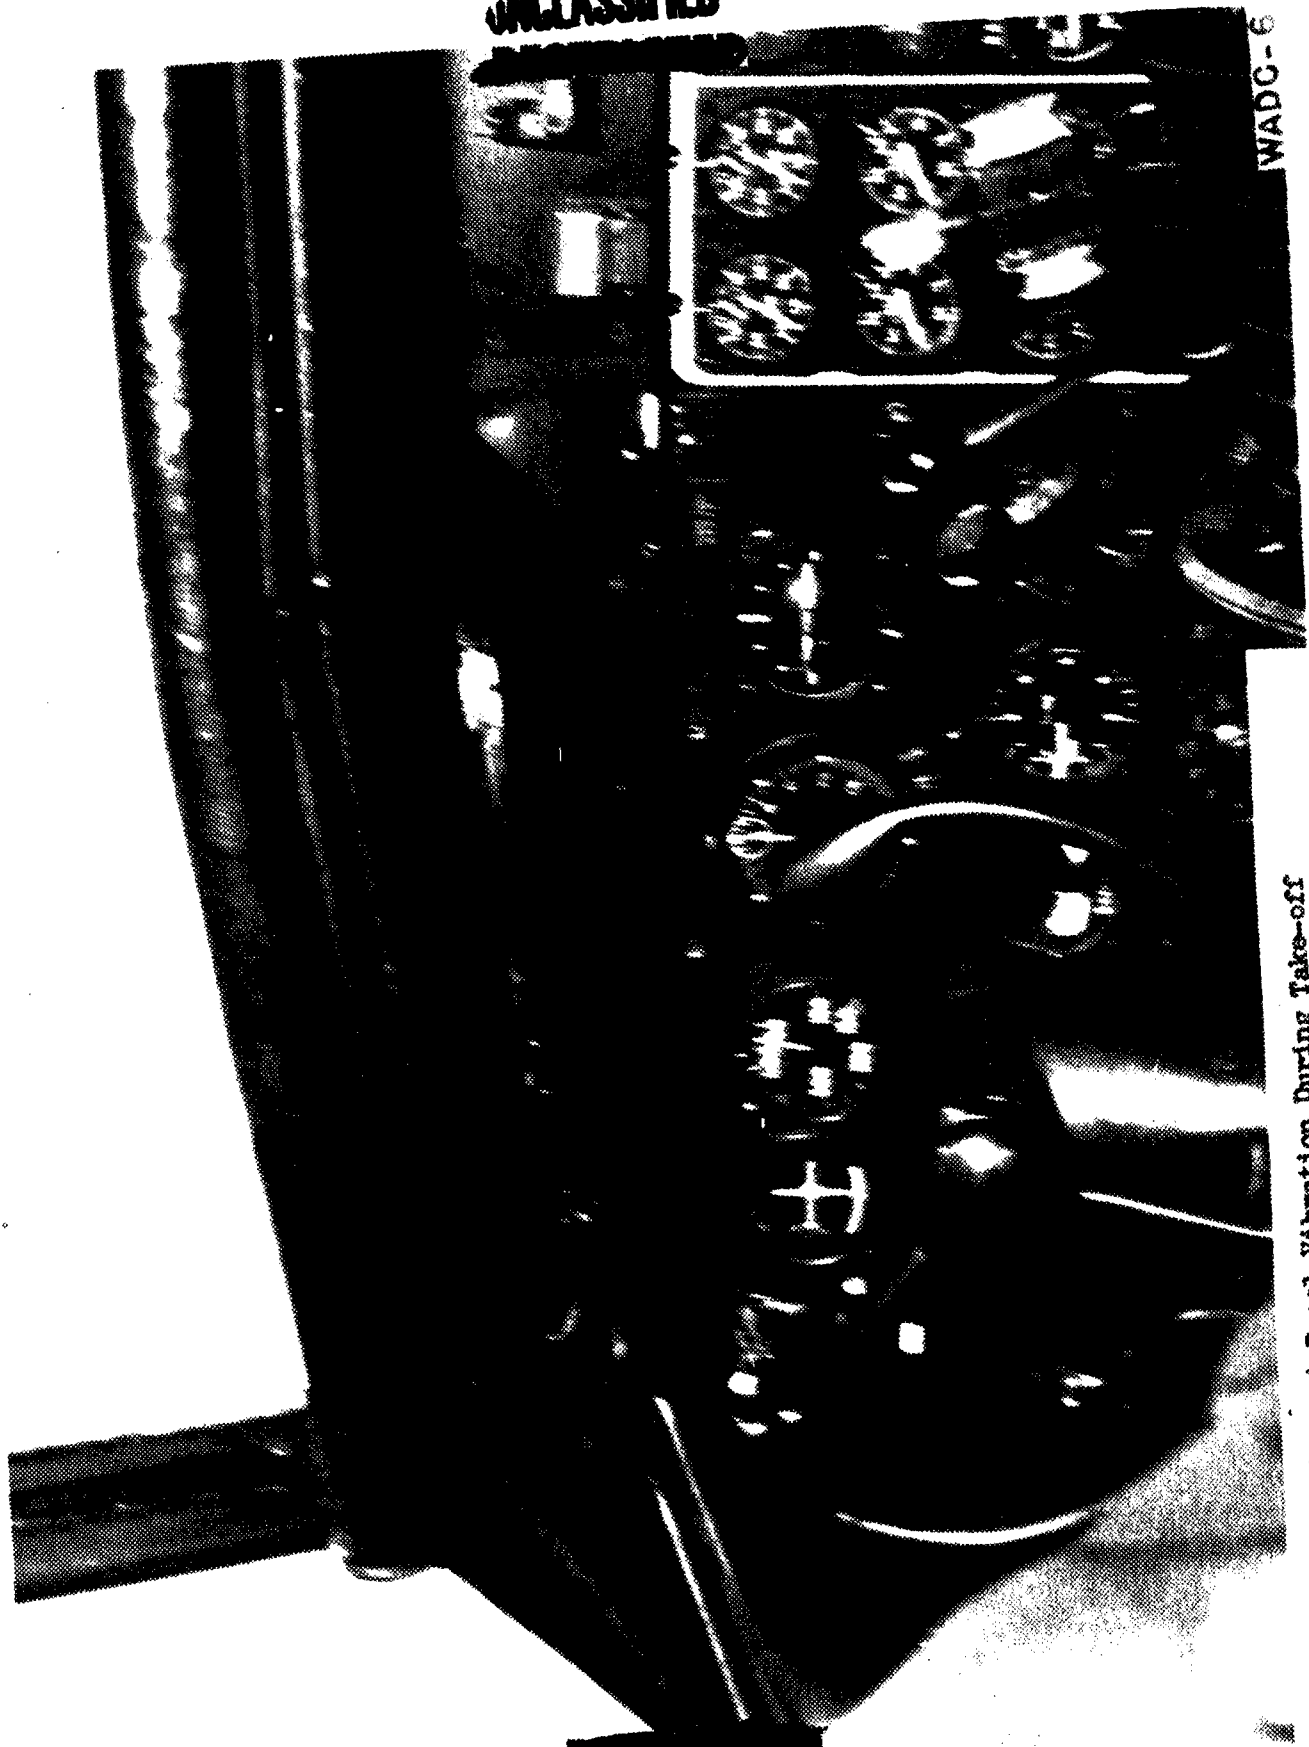
Fig. 7 - Instrument Panel Vibration During Take-off

Directional control is easily maintained by use of the steerable nose wheel until the rudder becomes effective. Severe vibration of the instrument panel at speeds between 40 and 60 knots, however, makes it difficult to read the heading indicator, and should a swing develop, it is unlikely that it would be noticed immediately by reference to the instruments alone. (See Fig 7).
